Part One: Conserving the Treasured Wall Fabrics of the Turkish Ballroom 2002-2007

Julia M. Brennan
ARCA Washington DC
Correspondent

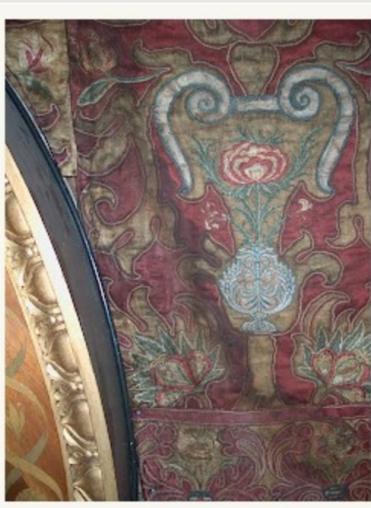
Nearly 100 years in situ had severely damaged the 515 square feet of wall fabrics. Visible from the floor, about 25% of the fabrics were in severe condition - badly stained, disintegrating, falling apart, and truly disfigured. Huge black stains around window frames marked where the silks were completely rotted. From a cursory examination on ladders, it was evident that the silks and backing fabrics were dry rotted, huge holes proliferated, the stains and encrustations had deteriorated the multiple layers of fabric in areas, the roof and window leaks had leached lime and plaster into the fabric - in short it was going to be a huge challenge!

Detail of stains

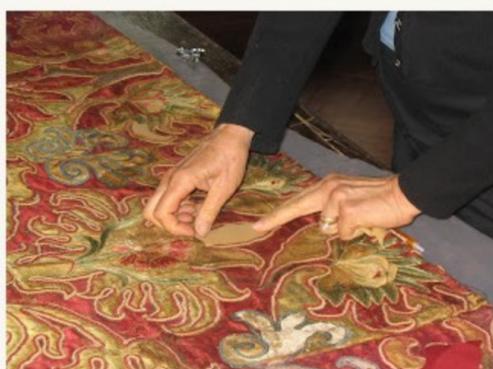
Inserting silk panels

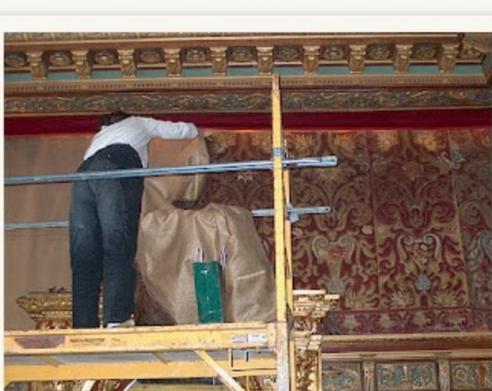
In the initial stages of conservation research, we took down one smaller panel for examination and analysis. This permitted deconstruction and analysis of the entire construction, techniques and fabrics/materials.

De-installing panels in 2003
